Architectural and Landscape Survey of Camp Guernsey, Wyoming

Adam D. Smith, Megan W. Tooker, and Sunny E. Adams

June 2017

Under Project Number 458417, "Camp Guernsey Historic Context and Building
Evaluation"

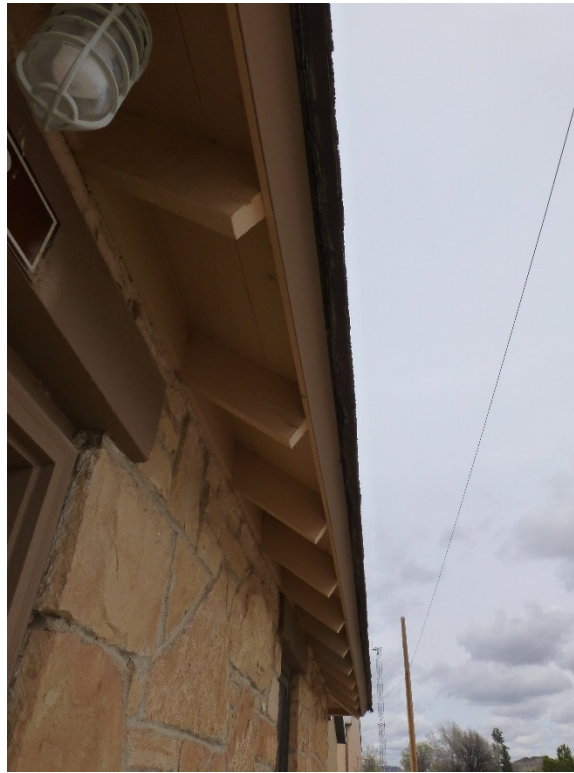
Figure 59. Close-up of the original exposed wood rafter tails on the original portion of Building 012 at Camp Guernsey (ERDC-CERL, 2016).

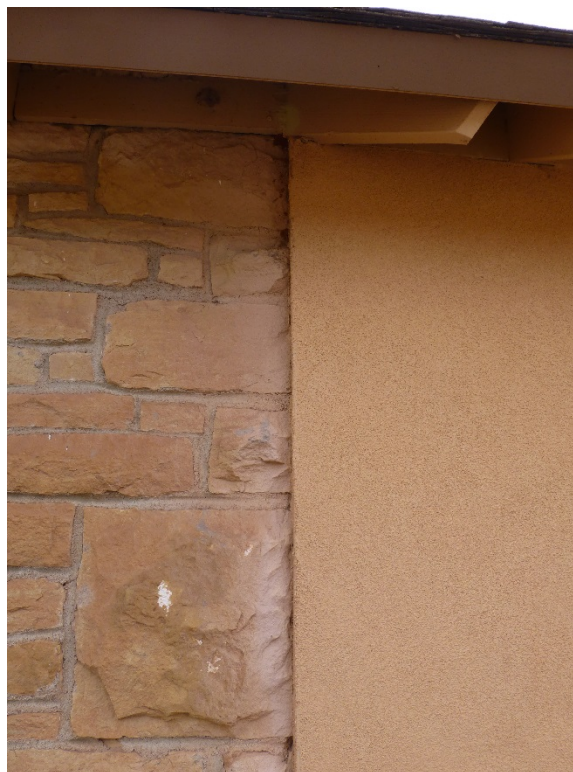
Figure 66. Close-up of the connection between the original stone exterior wall and overhanging eave with rafter [left] and the modified addition now clad with synthetic stucco material [right] on Building 012 at Camp Guernsey (ERDC-CERL, 2016).

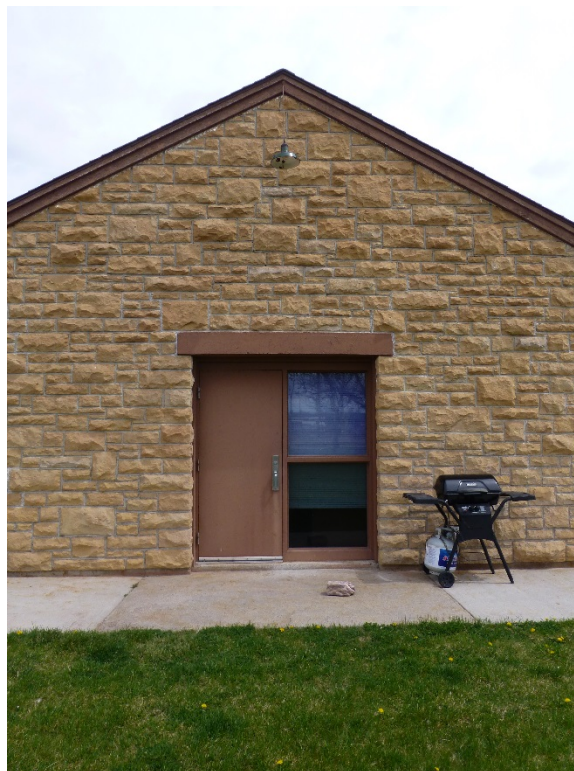
Figure 144. Replacement metal door with two-pane side light on the west elevation of Building 101 at Camp Guernsey (ERDC-CERL, 2016).

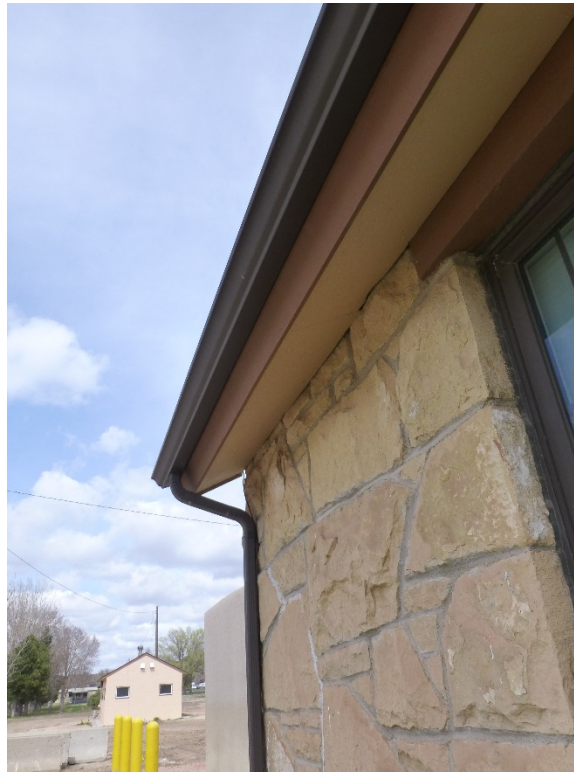
Figure 189. Close-up of the modified overhanging eave on Building 201 at Camp Guernsey (ERDC-CERL, 2016).

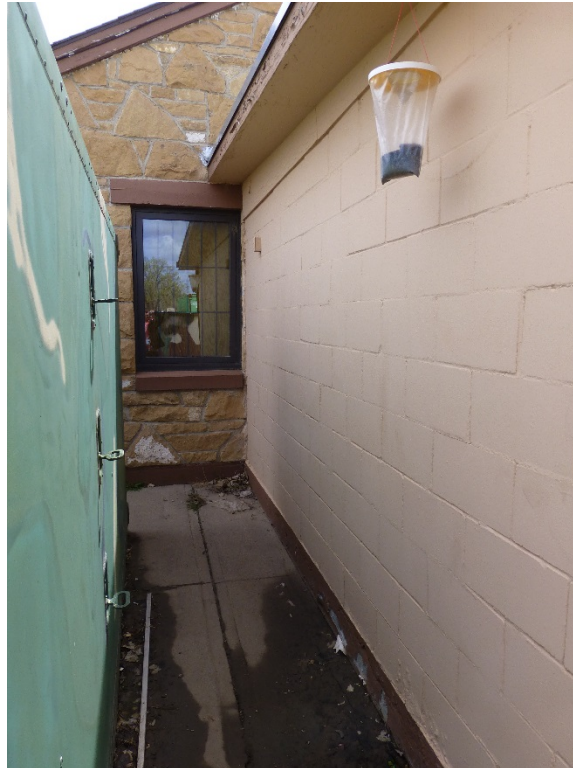
Figure 202. Close-up of the connection between the original stone wall and the concrete block addition on the north side of Building 201 at Camp Guernsey (ERDC-CERL, 2016).

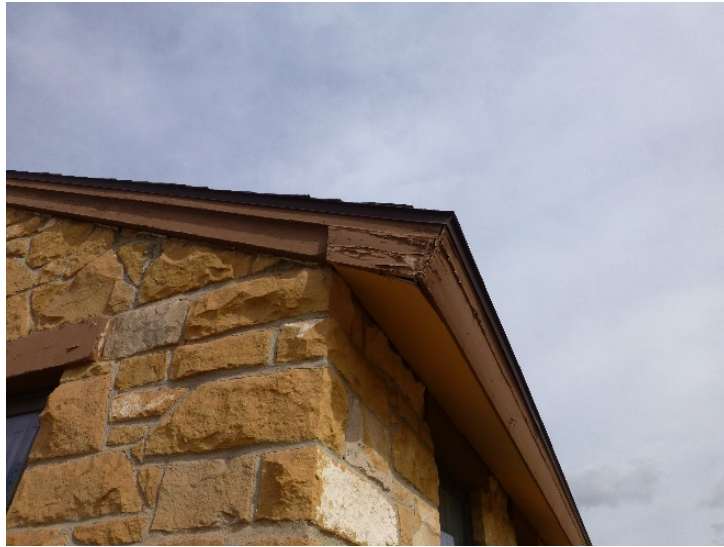
Figure 211. Overhanging eave modified with wood fascia and soffit covering the original exposed wood rafter tails on Building 216 at Camp Guernsey (ERDC-CERL, 2016).

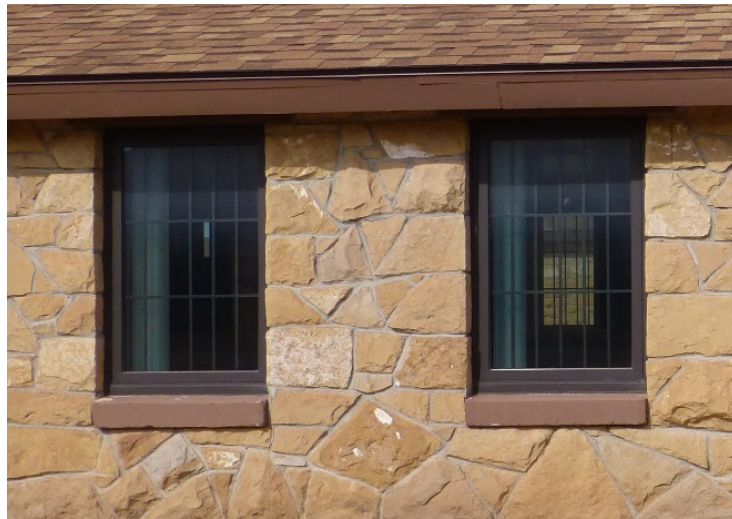
Figure 212. Replacement, single-pane, anodized-bronze aluminum windows on Building 216 at Camp Guernsey (ERDC-CERL, 2016).

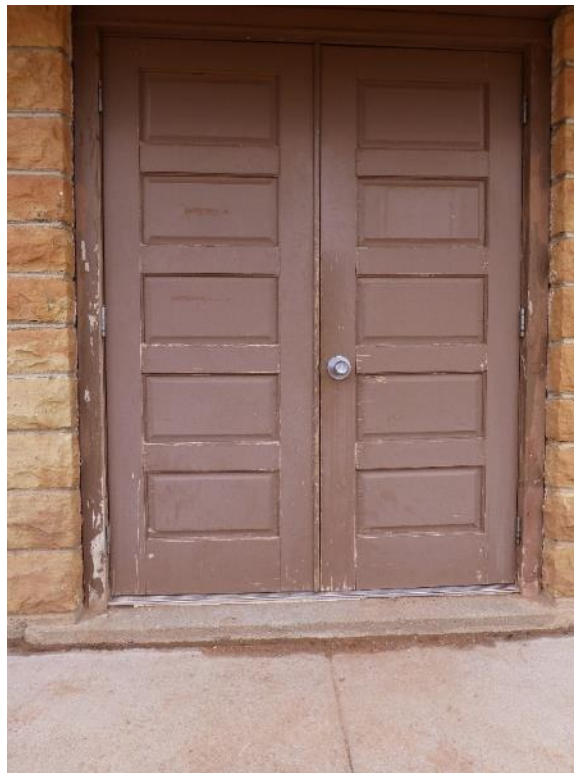
Figure 299. Original wood panel door on the east elevation of Building 315 at Camp Guernsey (ERDC-CERL, 2016).
